## STS-107 FLIGHT READINESS REVIEW

# BACKUP INFORMATION

# STS-109 PREVIOUS FLIGHT ANOMALIES BACKUP

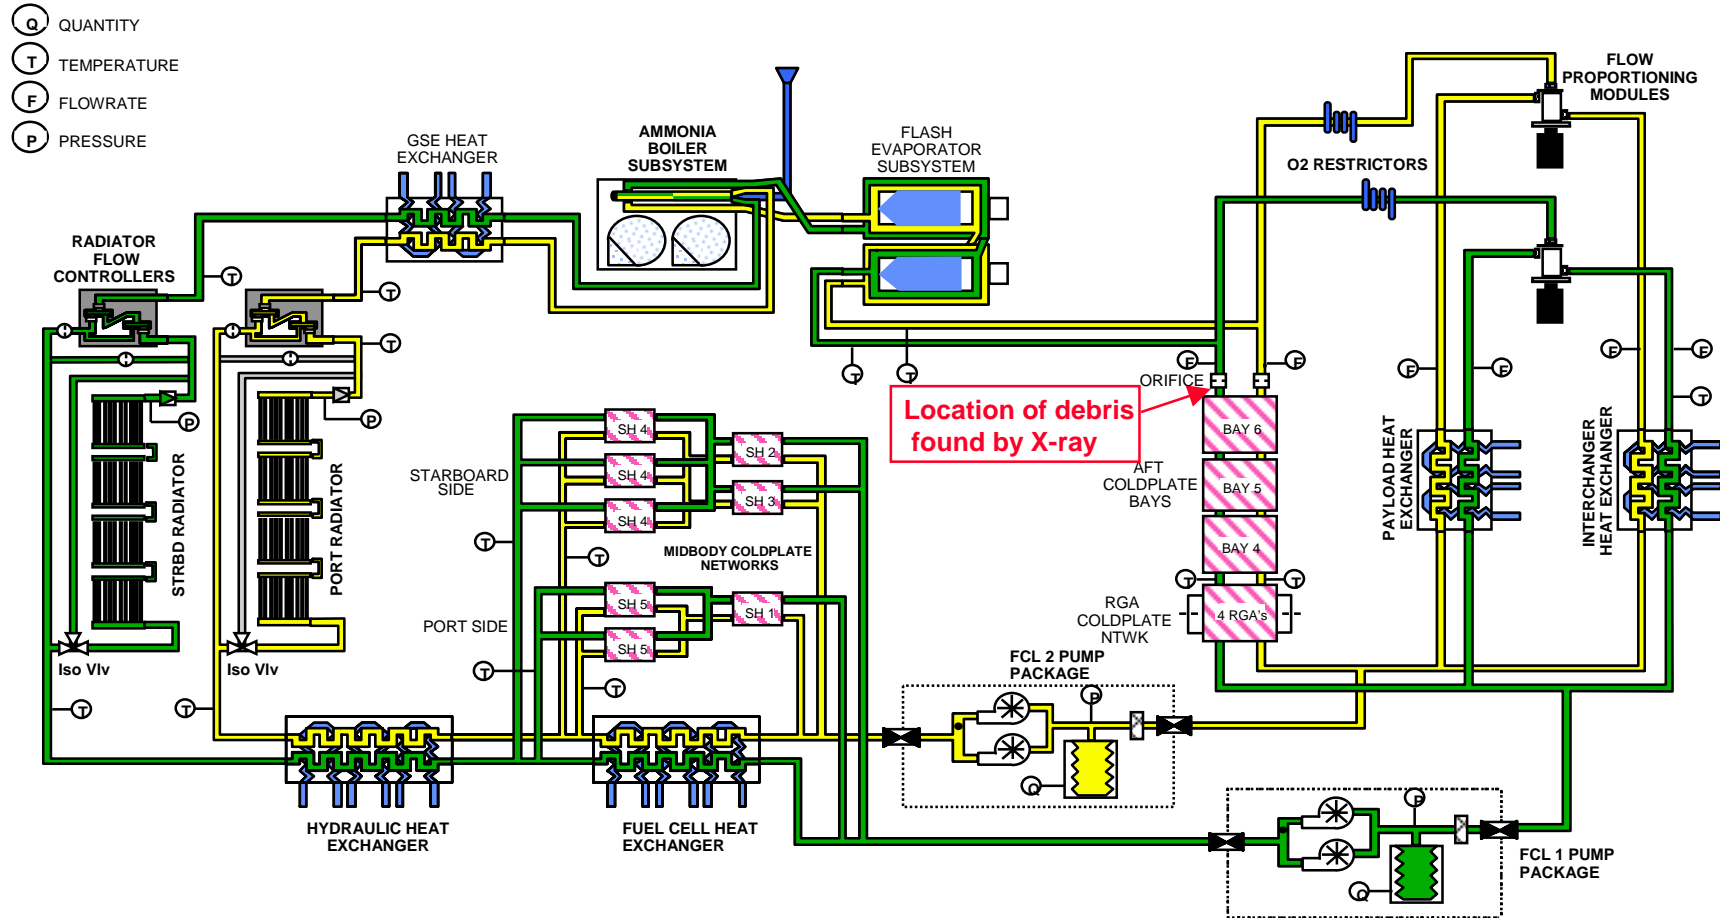
## ORBITER ACTIVE THERMAL CONTROL SYSTEM (ATCS)

- Freon coolant loop (FCL) 1 aft cold plate (ACP) flow dropped from 305 to 225 lbs/hr after MECO

- Approximately ten minutes after lift-off, the FCL 1 ACP flow rate dropped from 305 lbs/hr to 225 lbs/hr, then to 195 lbs/hr when the FCL was reconfigured to rad flow
  - Data review confirmed that the flow reduction was caused by a restriction in the ACP leg
- The flow rate stabilized, and analysis determined that adequate flow would still be available to provide sufficient cooling for the remainder of STS-109

- The debris that caused the flow restriction was removed
- Additional x-rays taken at potential debris traps in both loops and visual inspection of FCL 1 FPM & pump inlet filters verified acceptable system cleanliness
  - FPM 1 and pump inlet filters replaced
- Freon systems have been verified through OMRSD testing

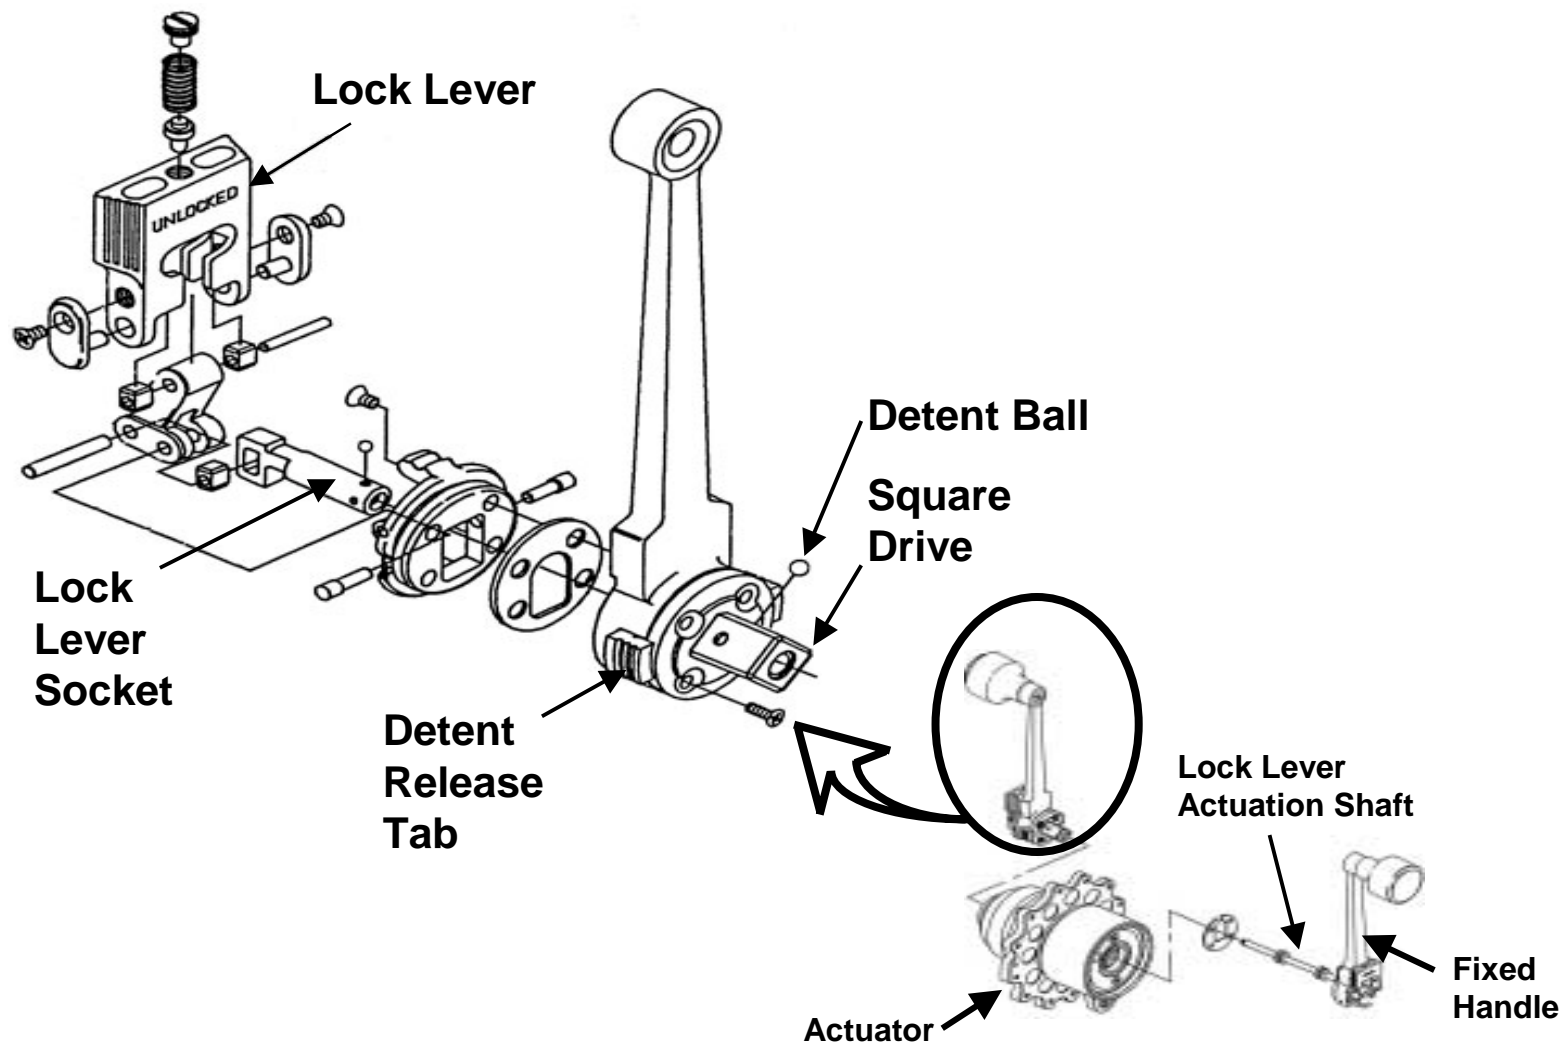
**STS-109-V-02: AIRLOCK A HATCH  
LOCKING DEVICE DIFFICULT TO  
ACTUATE**

- The removable handle on the crew module side of this actuator must be fully seated in order for the lock lever socket to be properly engaged
  - With the handle unseated, lock lever can move separately from the rest of the lock mechanism
- During final hatch closeout for flight, handle was noted to be fully seated, and actuator functioned properly

- On-vehicle post-flight troubleshooting revealed that the actuator handle release tabs did not spring back after being depressed
  - Handle became unseated when lock lever was moved
- Removed the handle/actuator assembly and sent it to the NSLD for TT&E and repair

- All hatch actuators on OV-102 have been functionally tested, with emphasis placed on verifying proper handle release tab operation
- Worst case, inability to unlock the “A” hatch actuator is a crit 1R/2 failure because it results in losing the ability to perform a contingency EVA if required

- The actuator/handle was replaced, and functional verification has been completed
  - Permanent OMRSD requirement being considered

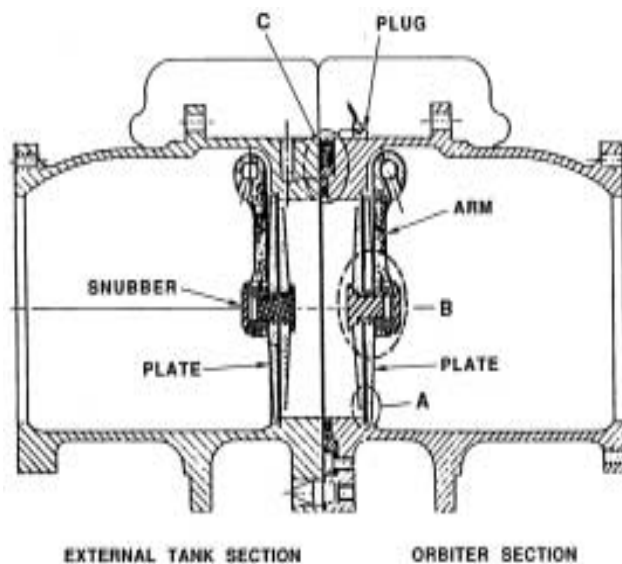
MATED 4" DISCONNECT

- MPS LH2 4" disconnect failed to close pneumatically when commanded at MECO
  - Closed via back-up mechanical mode at ET/Orbiter umbilical separation

- Failure of the 4" disconnect to close pneumatically in the case of a pre-MECO SSME shutdown or pad-abort results in inability to isolate the affected SSME from the hydrogen in the ET
  - No concern for nominal mission
    - Minor helium loss during entry if disconnect fails to close in back-up mechanical mode

- Inspection of Orbiter disconnect post-landing for indications of failure
  - Initial runway inspection revealed nothing unusual
  - Borescope inspection found Flourogold spacer (spool which negator spring slides/rotates on) cut and bent in towards springs
    - Scuff mark found on back of housing
- Disconnect R&R complete
  - Borescoped new disconnect and verified no damage
  - Leak checks complete and good
  - Removed PD3 failure analysis to follow
    - Ambient & cryo cycle tests

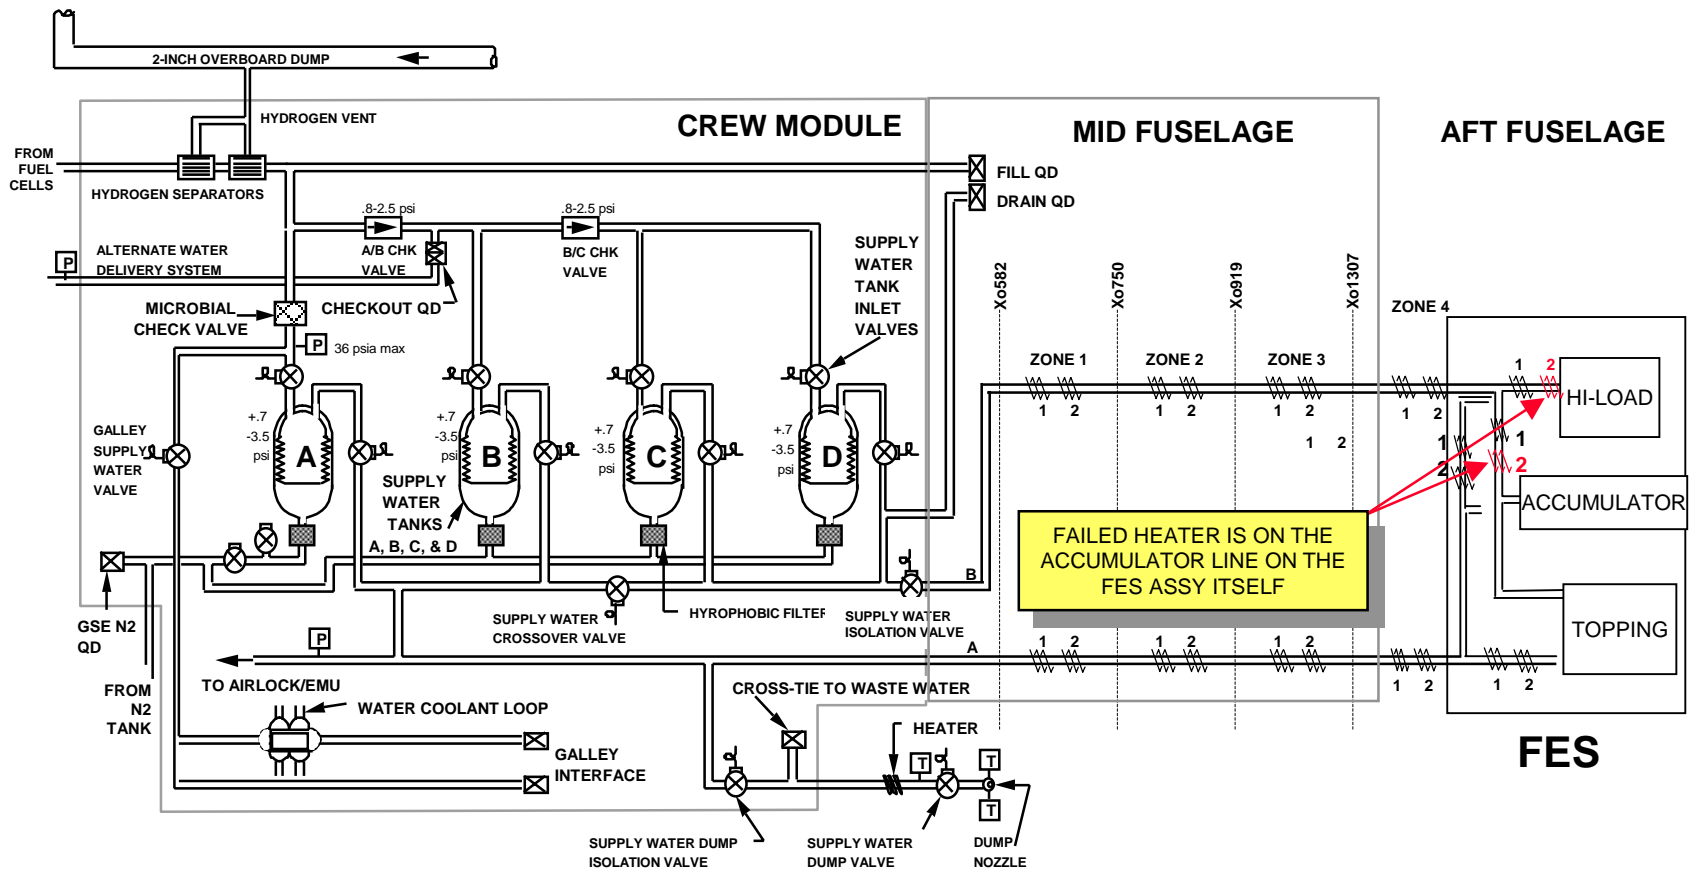
## SUPPLY WATER SYSTEM

<b>STS-109-V-05: FES ACCUMULATOR/HI-LOAD FEEDLINE B HEATER SYSTEM 2 FAILURE</b>	Presenter:
	Organization/Date: Orbiter 01/09/03

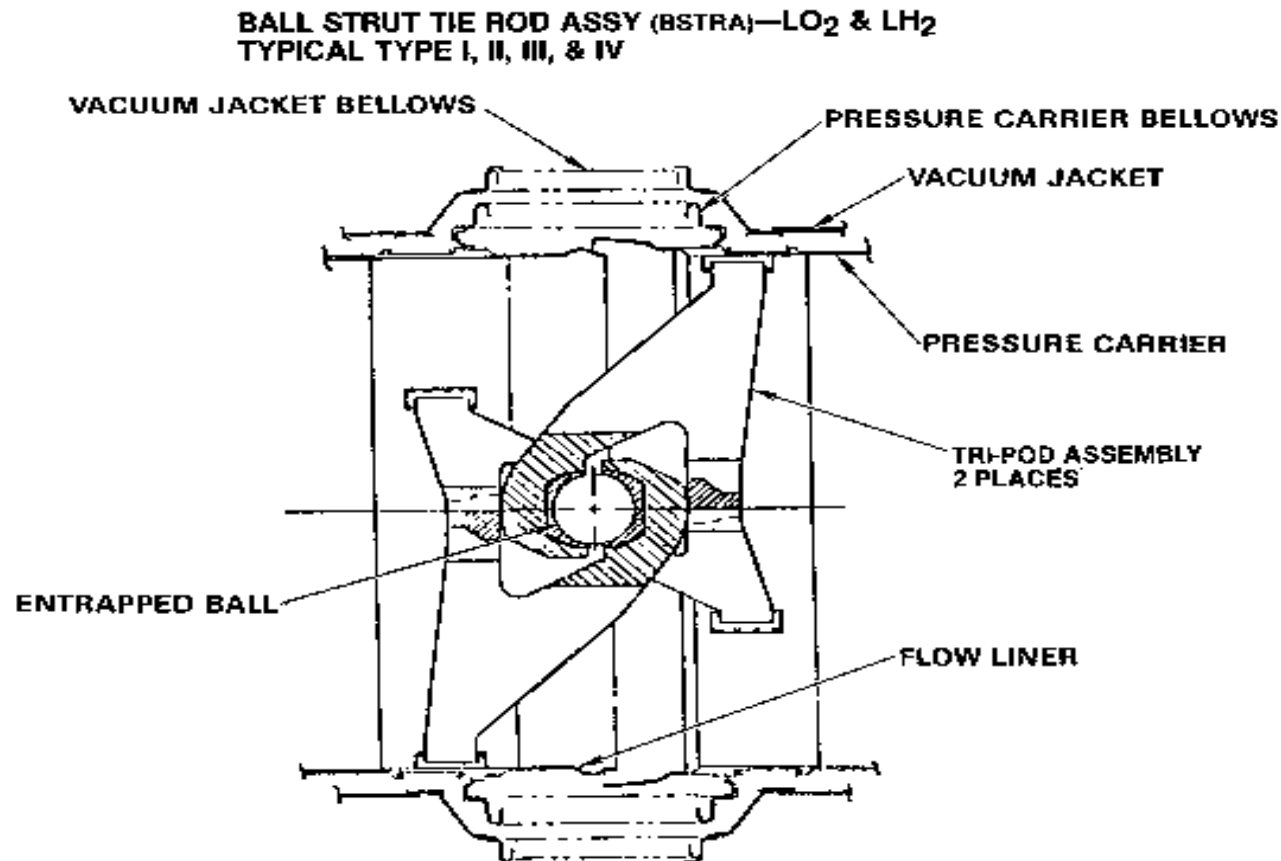
## Typical BSTRA Assembly

# MPS 17" Feedline Ball Strut Tie Rod Assembly Ball Crack
